DEPARTMENT OF TRANSPORTATION

Quality Assurance and Source Inspection

Contract #: 04-0120F4Cty: SF/ALA Rte: 80 PM: 13.2/13.9File #: 69.28**WELDING INSPECTION REPORT****Resident Engineer:**Pursell, Gary**Address:** 333 Burma Road**City:** Oakland, CA 94607**Report No:** WIR-001271**Date Inspected:** 17-Jan-2008**Project Name:** SAS Superstructure**OSM Arrival Time:** 730**Prime Contractor:** American Bridge/Fluor Enterprises, a JV**OSM Departure Time:** 1730**Contractor:** Zhenhua Port Machinery Company, Ltd (ZPMC), Changxing Island **Location:** Changxing Island**CWI Name:** Xu Xian Ping**CWI Present:** Yes No**Inspected CWI report:** Yes No N/A**Rod Oven in Use:** Yes No N/A**Electrode to specification:** Yes No N/A**Weld Procedures Followed:** Yes No N/A**Qualified Welders:** Yes No N/A**Verified Joint Fit-up:** Yes No N/A**Approved Drawings:** Yes No N/A**Approved WPS:** Yes No N/A**Delayed / Cancelled:** Yes No N/A**Bridge No:** 34-0006**Component:** OBG**Summary of Items Observed:**

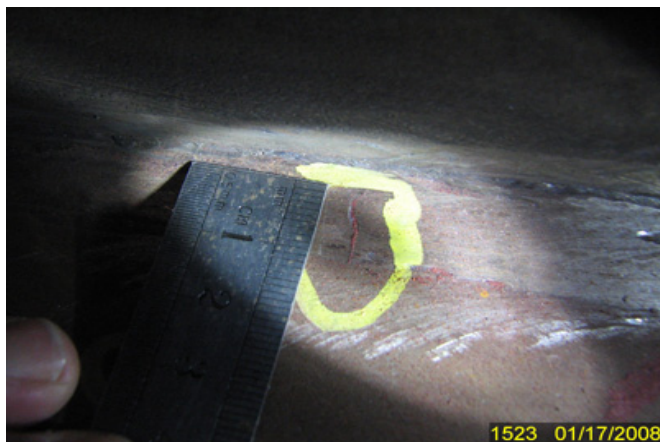
Caltrans QA Inspector Viars performed VT of OBG side plate SP030 fillet welds. During visual observations three transverse cracks were found on weld SP030-01-020, cracking was verified with Dry Magnetic Particle Testing. Cracking appeared to be propagating from the start and stop depressions of the manual Flux Cored Arc Welding (FCAW). ZPMC performed 10% MT prior to the Caltrans VT and MT verification. ZPMC Quality Control Mr. Shen Xue Jun stated the manual FCAW was performed due to an undersized weld condition of the original weld. ZPMC QC Certified Welding Inspector (CWI) Mr. Xu Xian Ping had previously accepted the visual inspection of the welds on the 22nd of December 2007. Areas of cracking were shown to American Bridge Flour (ABF) QC Mr. David LaRue. Mr. LaRue agreed with the Caltrans QA Inspector assessment. An Incident Report was issued for the QC oversight of the transverse cracking of SP030 fillet welds. ZPMC QC Shen Xue Jun stated additional magnetic particle testing would be required on the above mentioned fillet welds. Please see the attached photo below of the SP030 transverse cracking.
